# Corrosion

Published monthly as its official journal,  
by the National Association of Corrosion  
Engineers, Inc., at Houston, Texas, U.S.A.,  
as a permanent record of progress in cor-  
rosion control.

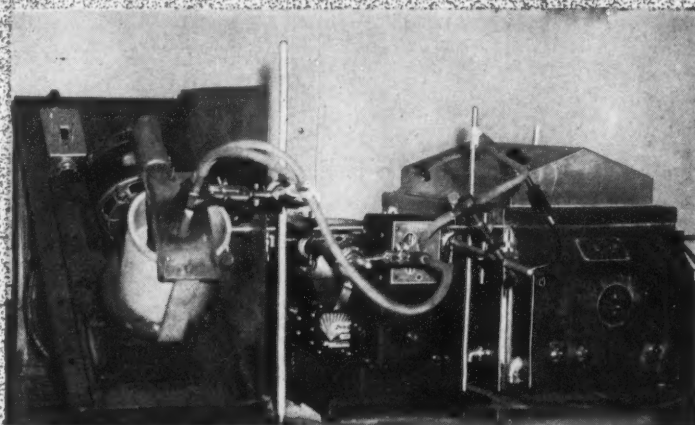
1

Figure 1—Wear-corrosion test mechanism.

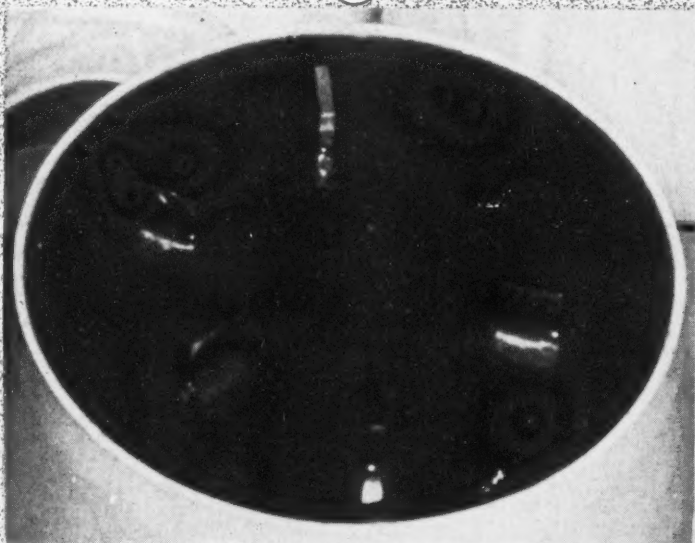
2

Figure 2—Method of mounting specimens for wear-corrosion tests.

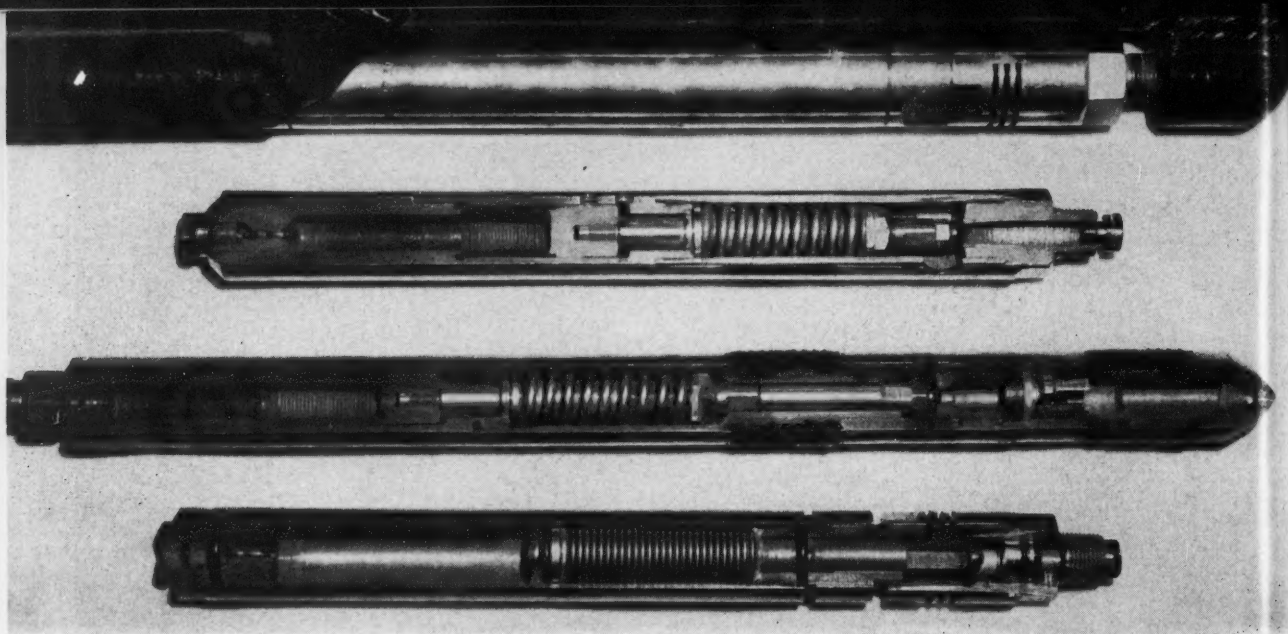
Figure 1—Cutaway sections of various flow valves and mandrel and valve assembly

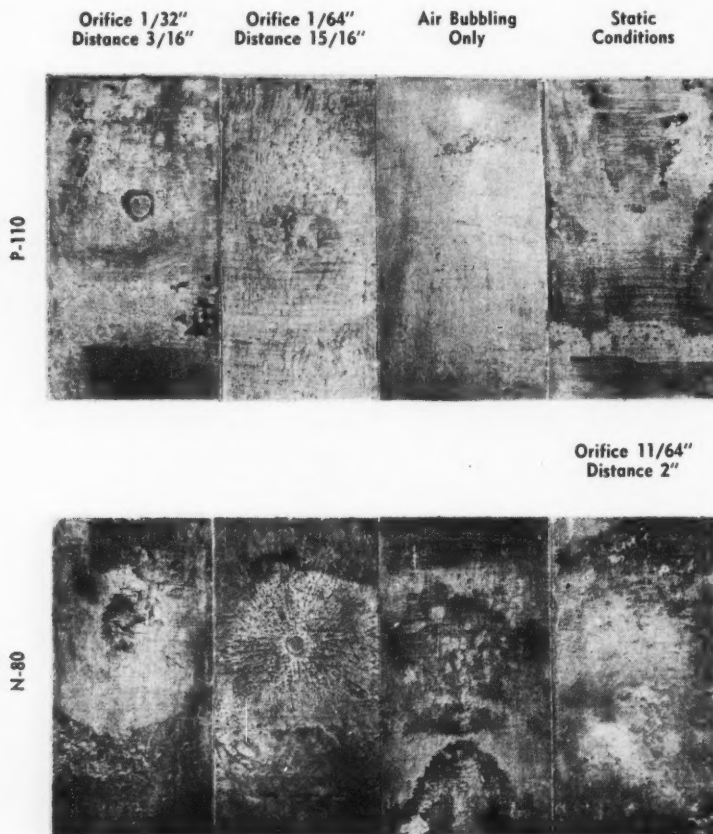
Figure 2—Pattern of corrosion attack on various steels subject to fluid impingement caused by air jet.

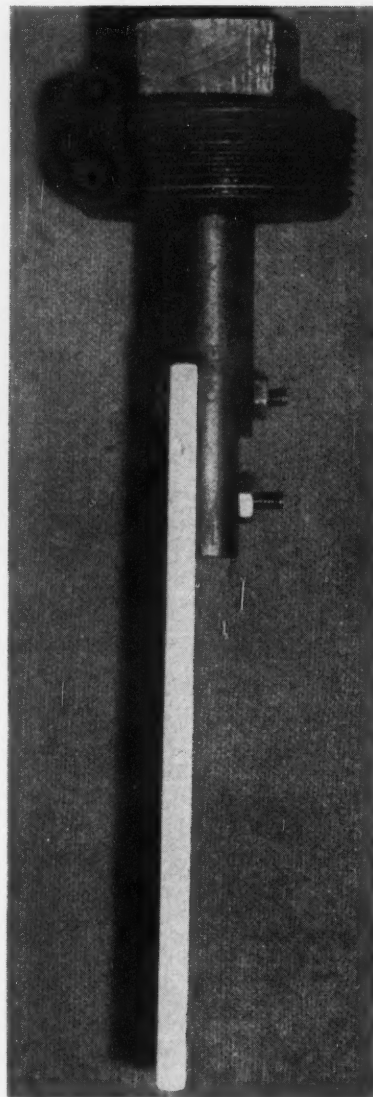
Figure 4—Mounting of coupons used in erosion studies.

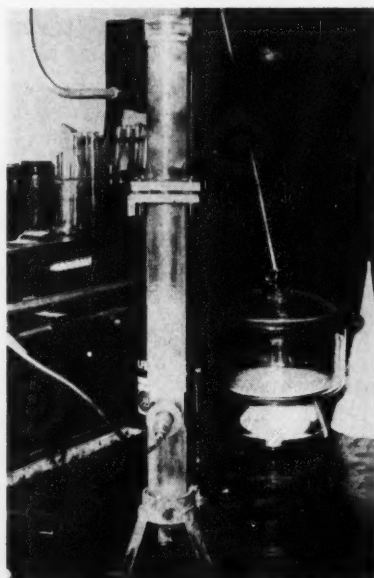
Figure 6—Laboratory set-up for testing ball and seat combinations.

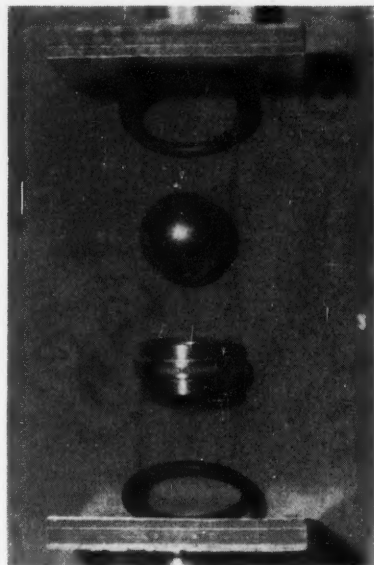
Figure 7—Detailed arrangement of ball valve in plastic holder.

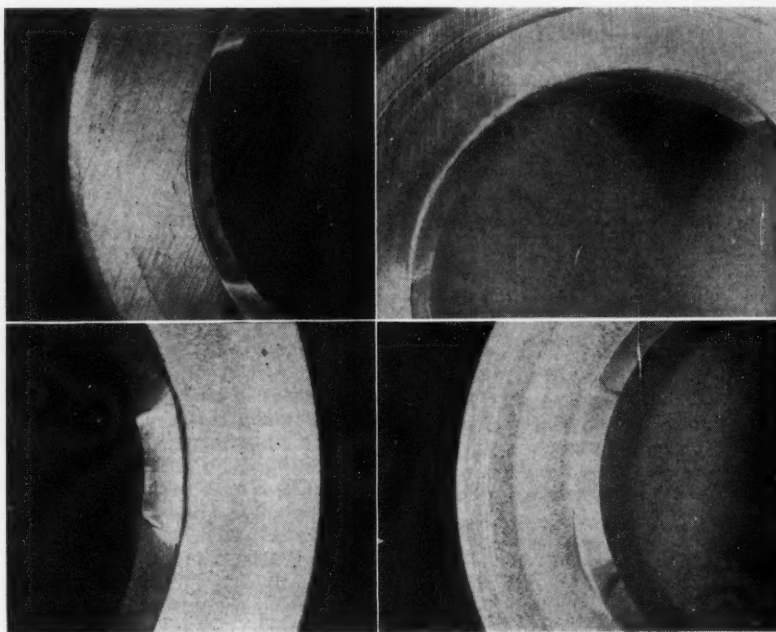
Figure 8—Close-up views of titanium seats showing erosion by well fluids.

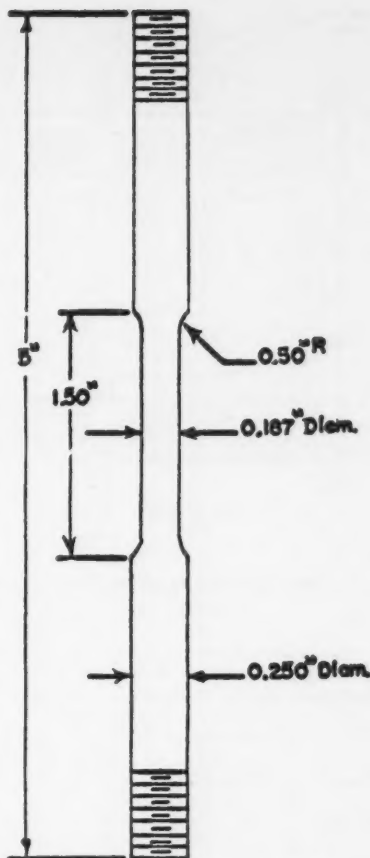
Figure 1—Tensile corrosion test specimen.

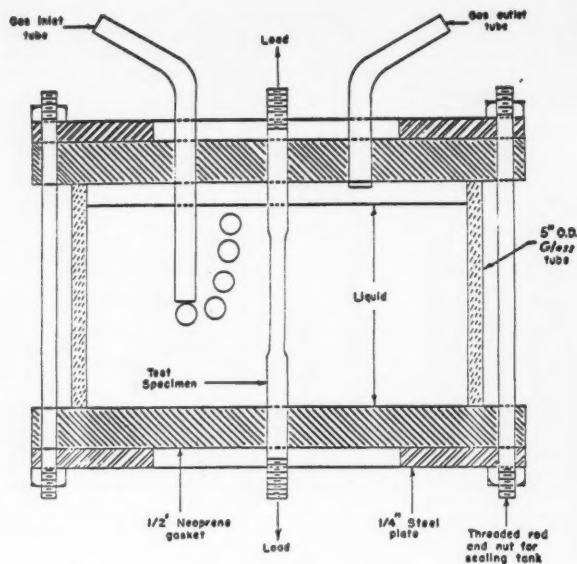
Figure 2—Cross section of tensile corrosion specimen in test jacket.

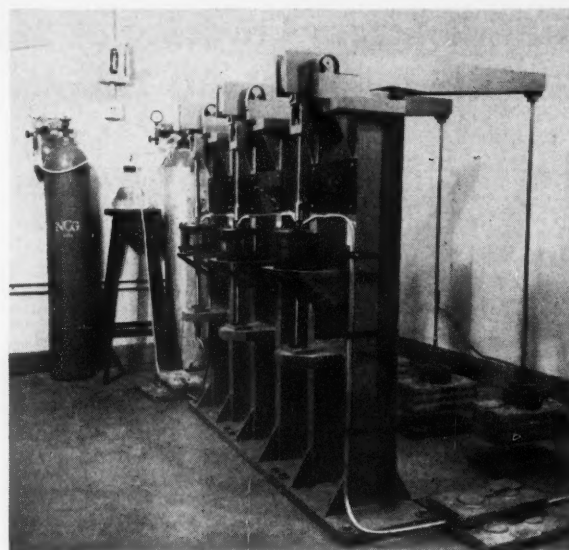
Figure 3—Creep machines for dead weight load testing of sulfide stress cracking specimens.

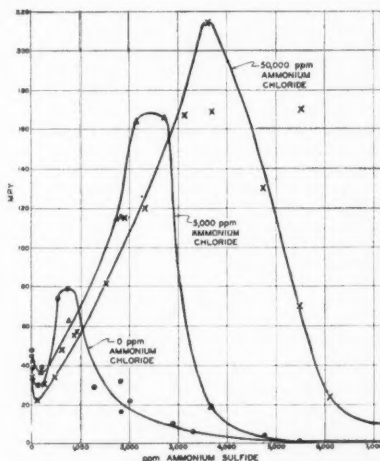
Figure 1—Effect of ammonium sulfide concentration on corrosivity of ammonium chloride hydrogen sulfide saturated brine in two phase agitated 140 F corrosion test (uninhibited).

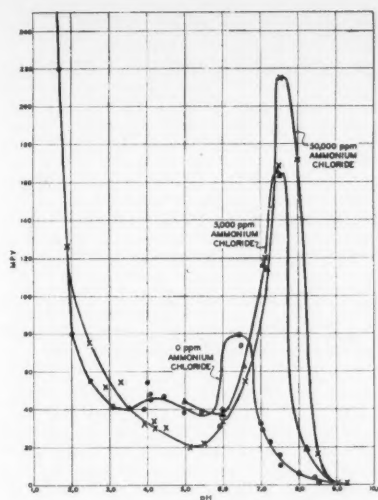
Figure 2—Effect of initial pH on corrosivity of ammonium chloride hydrogen sulfide saturated brine in two phase agitated 140 F corrosion test (uninhibited).

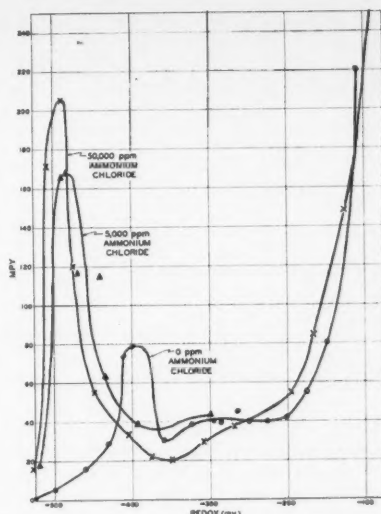
Figure 3—Effect of initial redox on corrosivity of ammonium chloride hydrogen sulfide saturated brine in two phase agitated 140 F corrosion test (uninhibited).

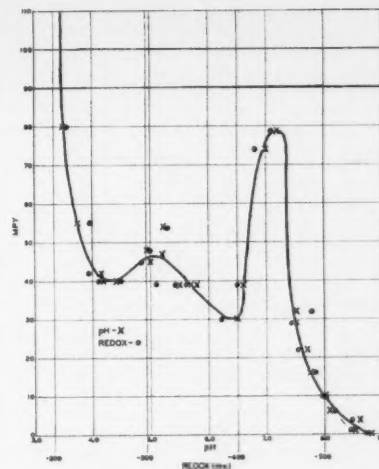
Figure 4—Effect of final pH and redox on corrosivity of hydrogen sulfide saturated water in two phase agitated 140 F corrosion test (uninhibited).

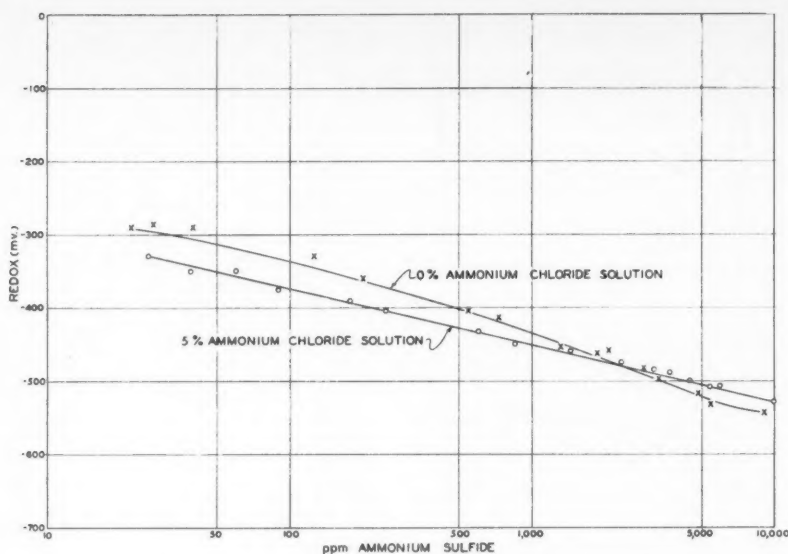
Figure 5—Change in redox with ammonium sulfide concentration in hydrogen sulfide saturated ammonium chloride solutions.

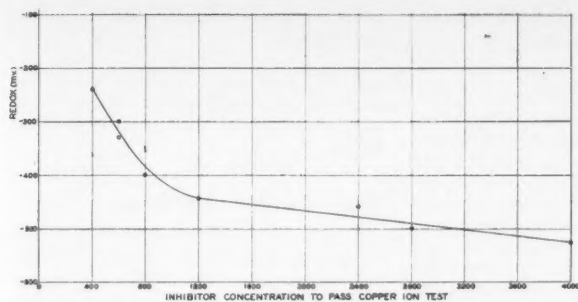
Figure 9—Inhibitor efficiency at various redox values in hydrogen sulfide saturated ammonium sulfide solution in copper ion displacement test.

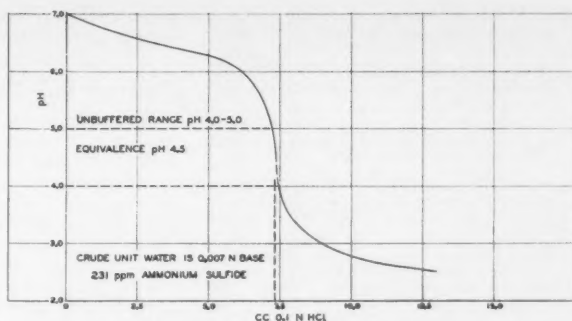
Figure 10—Typical electrometric titration neutralization plot of 100 ml refinery crude unit accumulator water with 0.1 N hydrochloric acid equivalence pH 4.5.

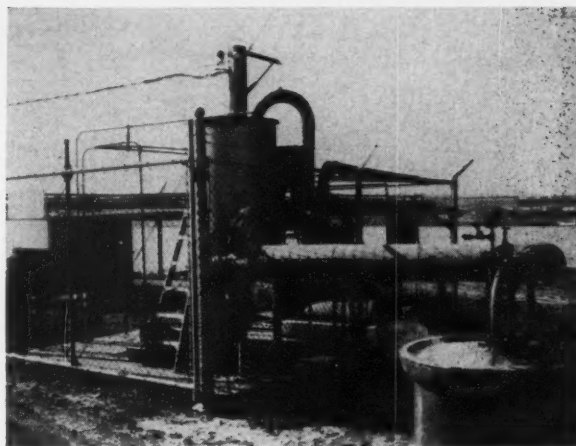
Figure 6—Raw waste, lifted from the sewer by a hydraulic ejector in the standpipe (right foreground), is discharged into the pump tank (upper center).

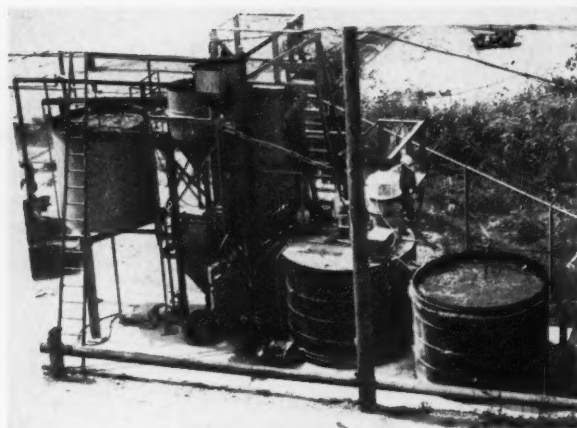
Figure 7—Neutralizer/pre-aeration tank (far right). Hold tank is second from right.

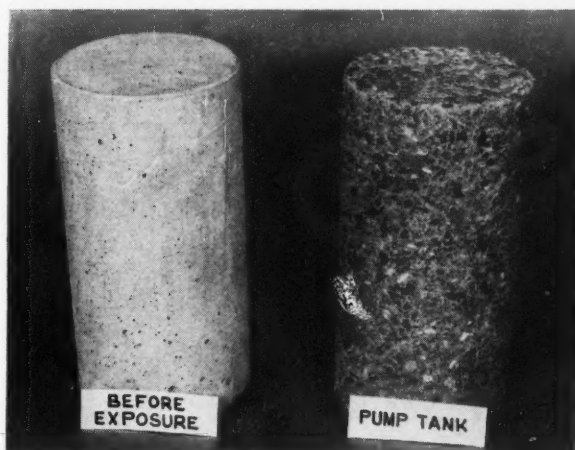
Figure 10—Concrete before and after exposure in pump tank. Note damage.

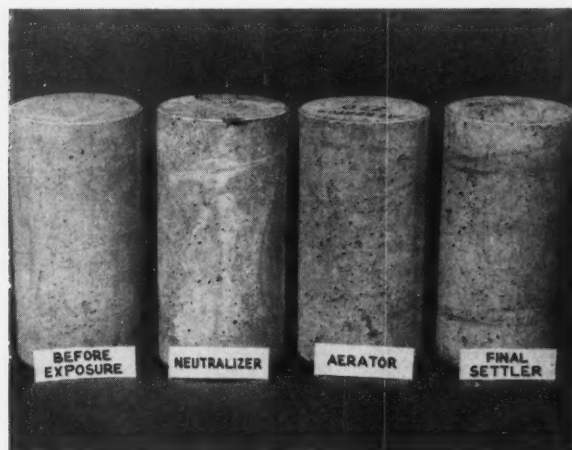
Figure 11—Concrete before and after exposure in neutralizer, aerator and final settler.

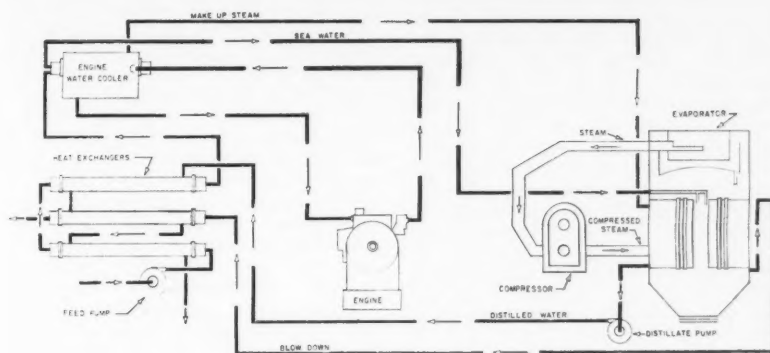
Figure 2—Schematic flow of distillation unit shown in Figure 1.

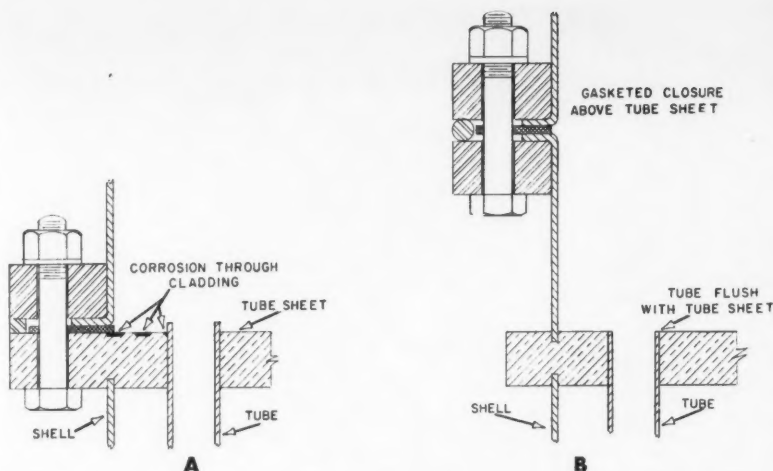
Figure 3—Corrosion of cladding on an evaporator tube sheet near closure shown in A; method of preventing such corrosion shown in B.

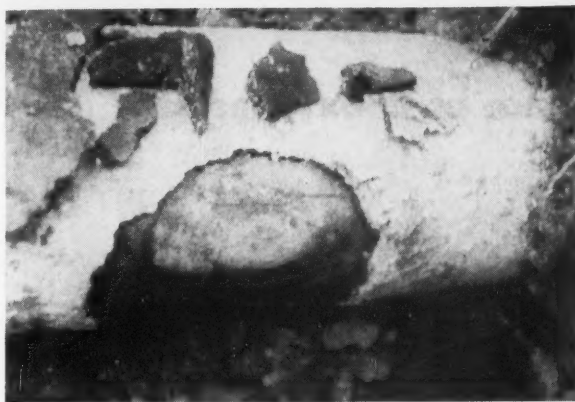
Figure 3—Pipe surface under lump in Figure 2. The pipe was rusted considerably, although no pitting was observed. Note the circular pattern of rust stains.

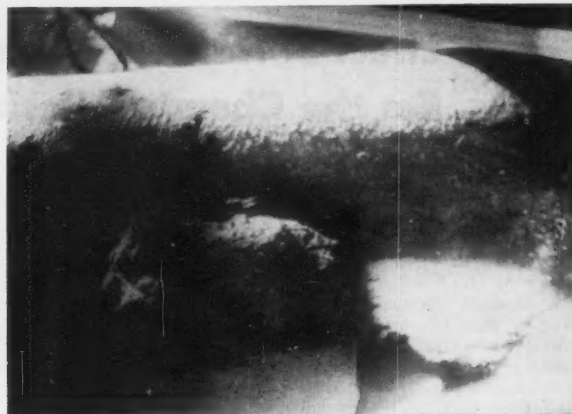
Figure 4—Discontinuity on bottom of pipe (photographed with the aid of a mirror). Soil lump was 4 inches thick and 5 inches wide. The length extended beyond the bell-hole.

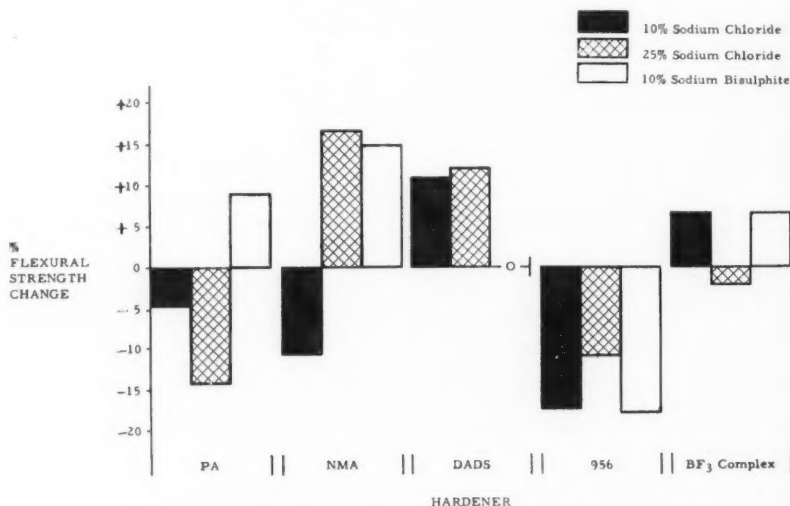
Figure 1—Percent flexural strength change after six months immersion in salts.

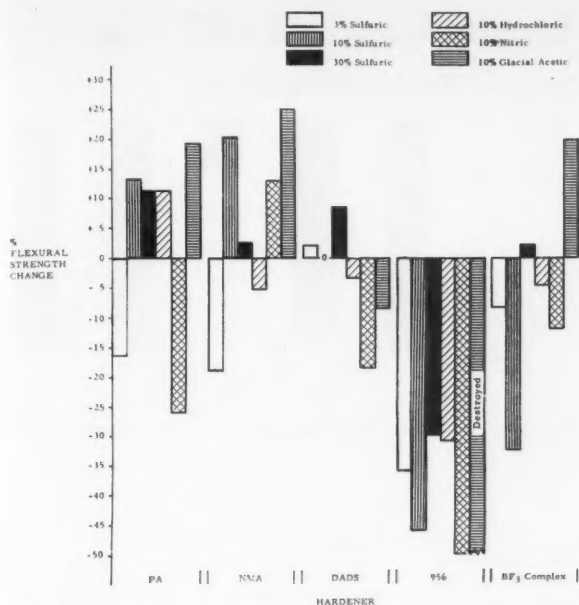
Figure 2—Percent flexural strength change after six months immersion in acids.

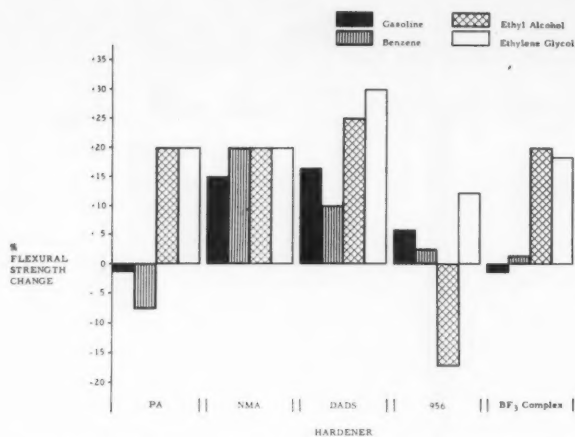
Figure 4—Percent flexural strength change after six months immersion in weak organic solvents.

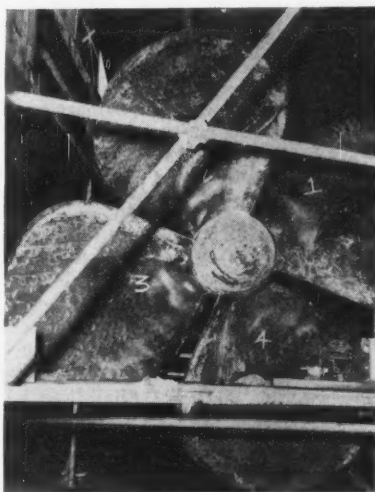
Figure 1—Cavitation damage on a destroyer propeller (port side).

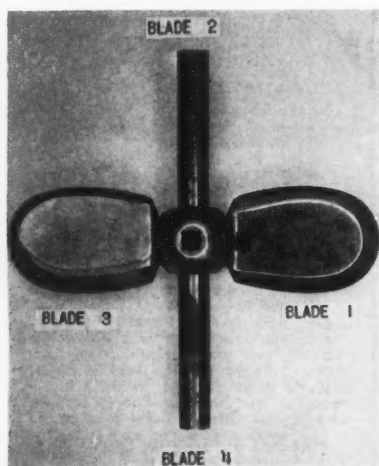
Figure 4—Multiple blade assembly used in cavitation study.

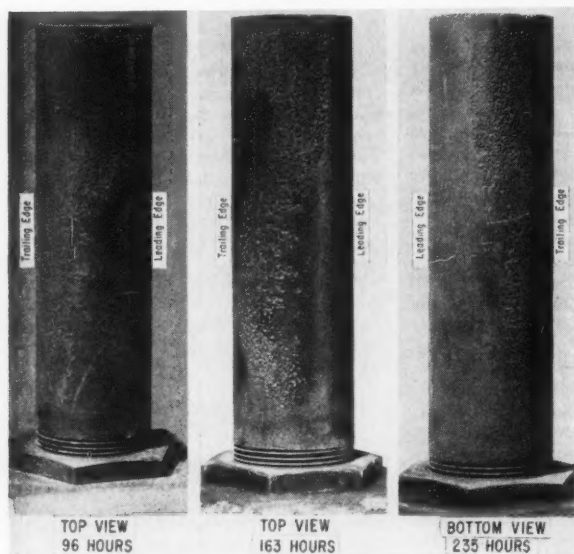
Figure 9—Boston cavitation tests on mild steel specimens; control—no cathodic protection, 1,250 rpm.

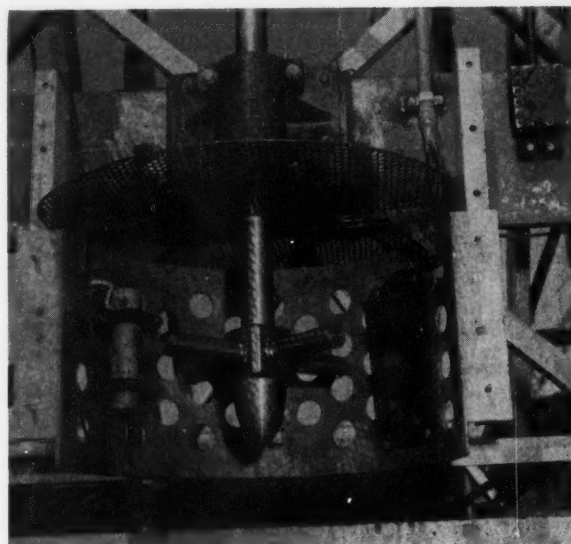
Figure 8—Close-up view of cavitation test propeller assembly.

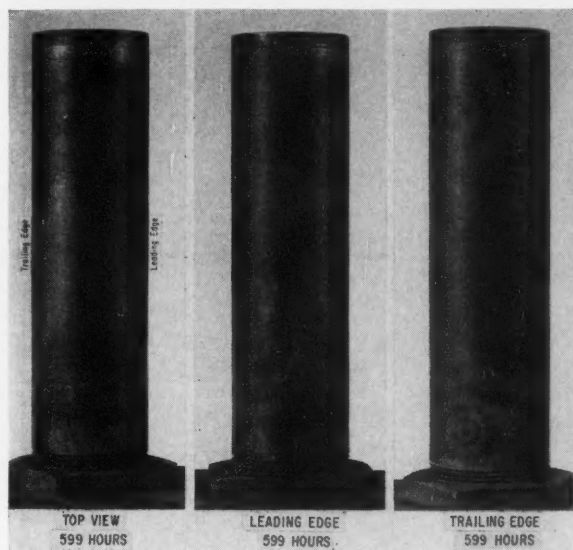
Figure 11—Boston cavitation tests on mild steel specimens (protected at 500 ma/sq ft, 1,250 rpm).

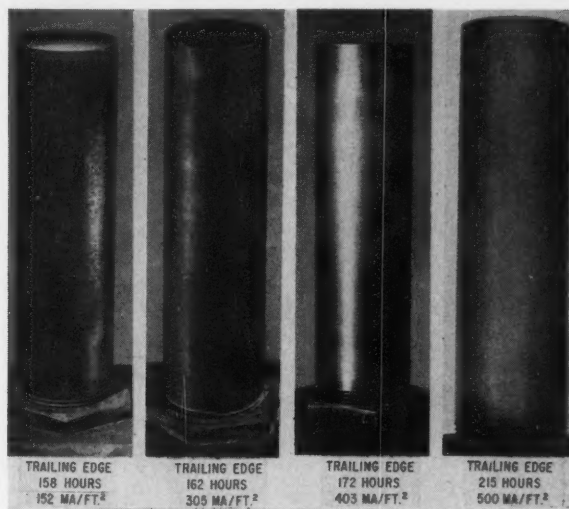
Figure 12—Boston cavitation tests on mild steel specimens showing progressively less damage with increasing cathodic current densities, 1,250 rpm.

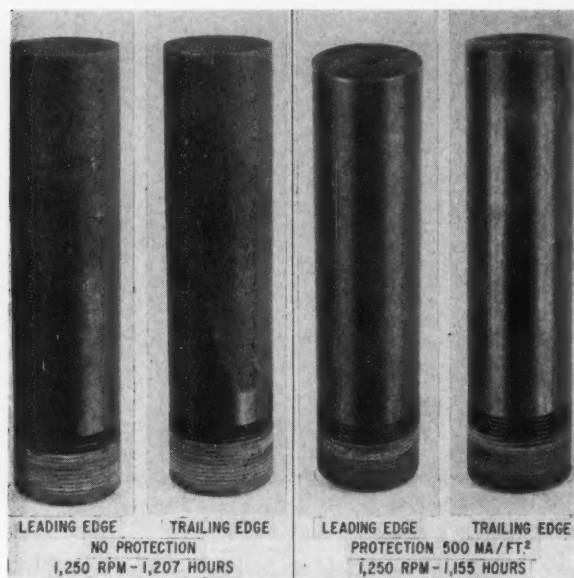
Figure 13—Boston cavitation tests on manganese bronze specimens.

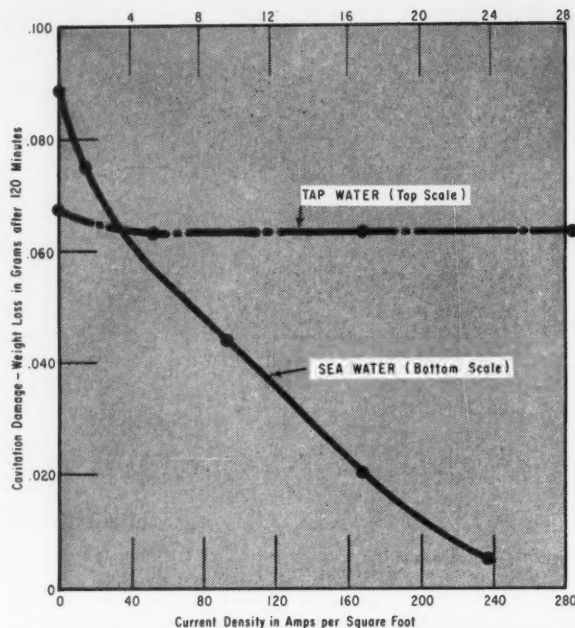
Figure 14—Cathodic protection of cast steel in water. Adopted from W. C. Leith, Dominion Engineering Co. Ltd., Canada (1955).

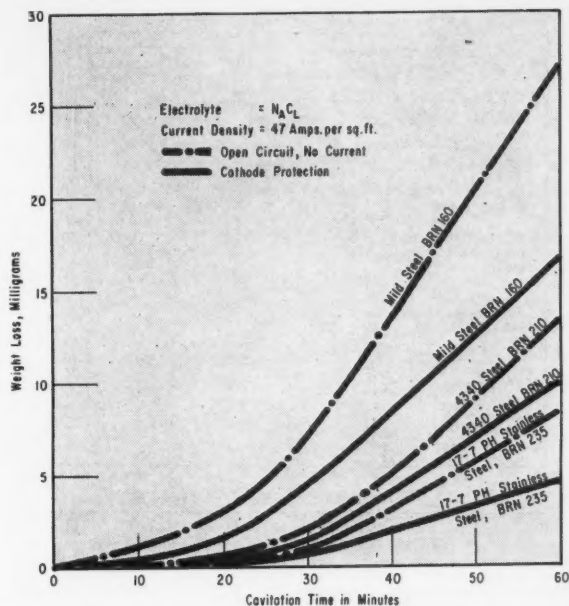
Figure 15—Cavitation damage under cathodic protection conditions (magnetostriction tests). Adopted from M. S. Plesset "on cathodic protection in cavitation damage." ASME paper No. 59A, 170 (1959).

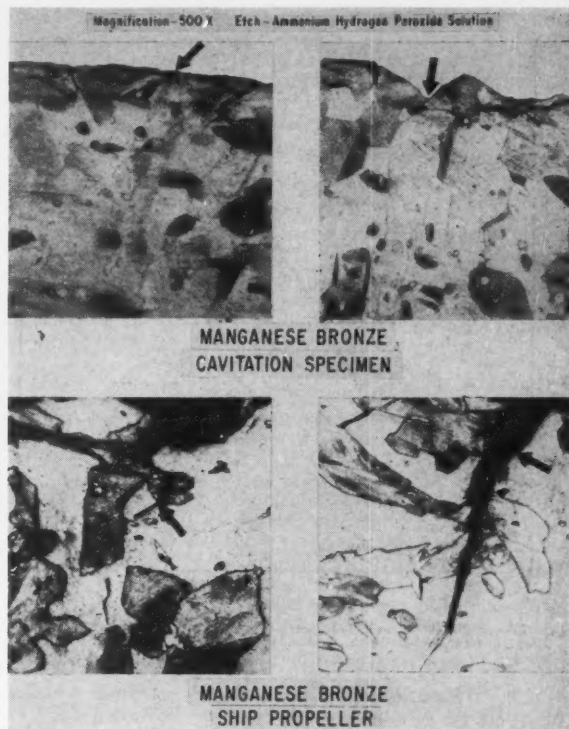
Figure 16—Photomicrographs of specimens and ship propeller showing similar fatigue crack formation during cavitation damage 500X, ammonium hydrogen peroxide etch.

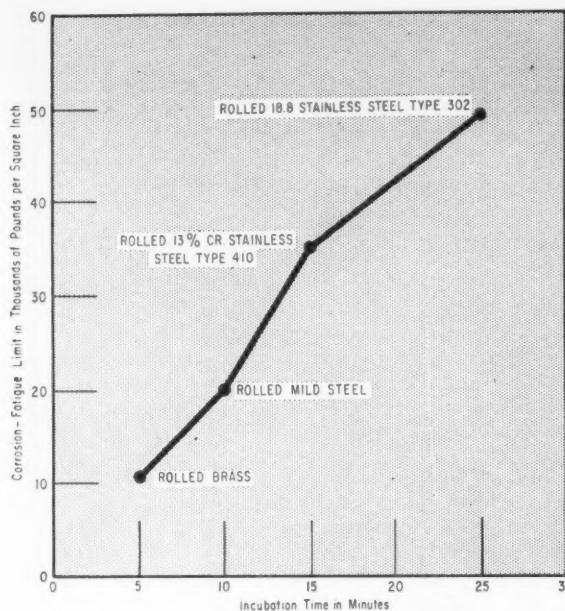
Figure 17—Graph of corrosion fatigue limit of metals and incubation time. Adapted from W. C. Leith, *Dominion Engineering*, 22, 3, 12 (1955).

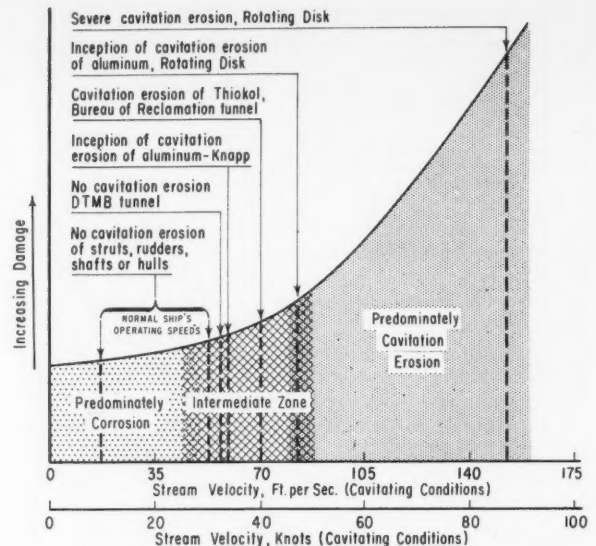
Figure 18—Relationship between fluid velocity and corrosion and cavitation damage of guiding surfaces. Adapted from J. F. Lichtman et al. *Trans ASME*, 80, 6, 1338 (1958) Feb.

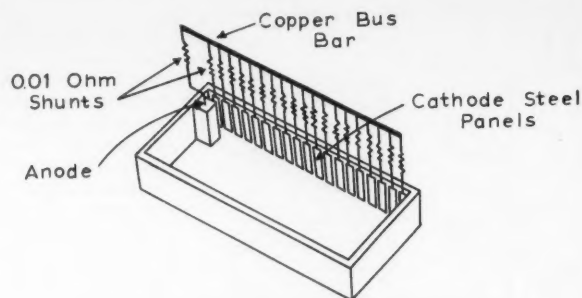
Figure 3—Arrangement of segmented steel cathode.
